North Slope of Alaska ARM Facilities Monthly Status Update Sandia National Labs

January 2017

INFORMAL AMF3 INSTRUMENT STATUS REPORT FOR January 20, 2017 - January 27, 2017

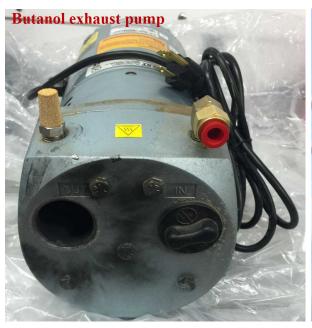
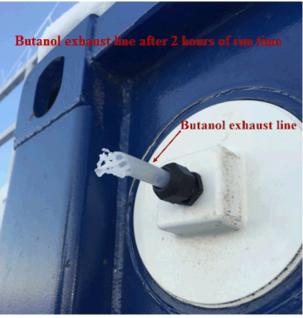
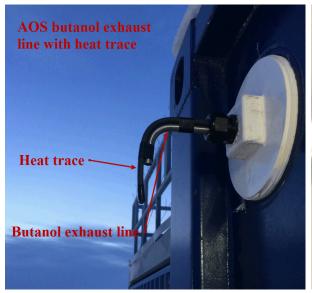
The AOS butanol exhaust line freezing shut. The AOS instruments using butanol had to be shut down due to butanol vapors being exhausted into the AOS and Artic Entry. It was found that the exhaust line was freezing shut. Even though the AOS mentors claimed there were no water vapors in the exhaust line. After clearing the line and modify the exhaust line the butanol exhaust pump was found bad. After replacing the pump the observers Ben and David came up with a fix seen in the last 2 photos.

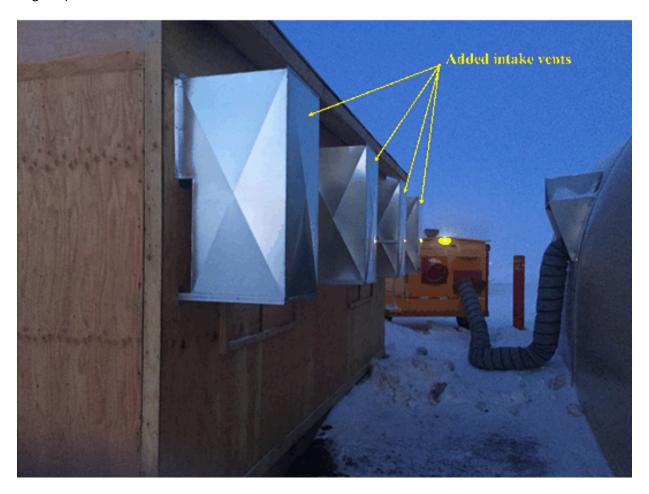
Overheating generator hooch: added four air intake vents and two power exhaust vents to the generator hooch. The power exhaust vents are thermostat controlled (on at 70 degrees and off at 60 degrees).

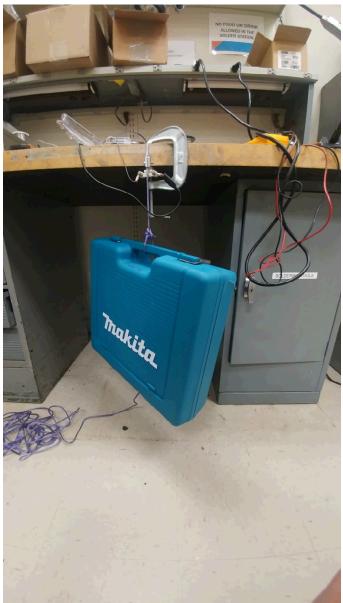
Figure 1: Lab burn wire test 1/24/17

- 5. A lab test of the Nichrome burn wire to separate the balloon and tether was successfully conducted. Balloon flights on Kirtland AFB in Albuquerque are planned for late February 2017 in order to test the burn wire and parachute deployment.
